**STATE OF CONSERVATION OF WORLD HERITAGE PROPERTY**  
**FORT AND SHALAMAR GARDENS, LAHORE**

### **STATE OF CONSERVATION**

#### **LAHORE FORT**

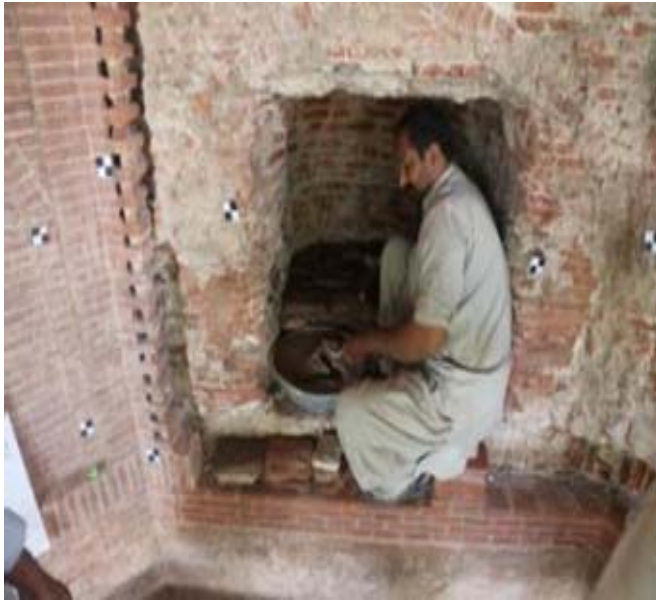
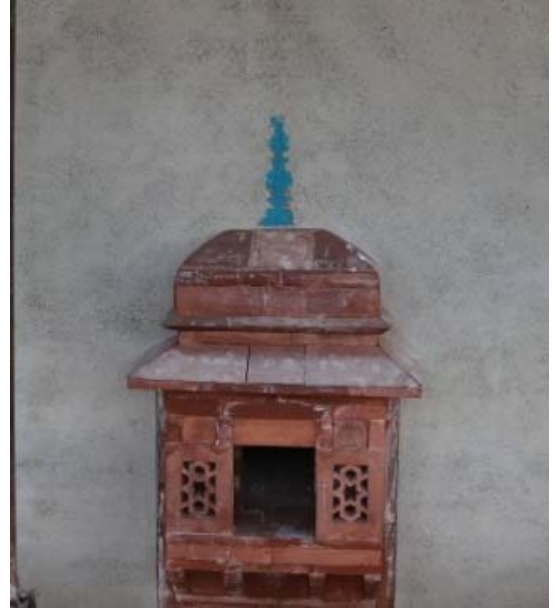
Restoration of Pigeon House

Many fresco panels on the Picture Wall have pigeon houses in the center. These houses are made of terracotta and tile mosaics and many of them have been damaged severely. A pigeon house was reconstructed on one of the fresco panels in the proto-type area for assessment. The same material and design has been used as the original pigeon house. Cut and dressed brick work was extensively used in the construction of Picture wall. This was a popular craft in the Mughal period where the fine joints between bricks were filled with lime mortar. In this technique, bricks are cut on exact size after which their size is checked and corrected with a gauge. Finally, these bricks are laid in lime mortar on the wall. Many of these original brick tiles were decayed due to salt crystallization and capillary uptake of water. The fragile brick were replaced with new cut brick tiles. The traditional method of cut and dressed brickwork was followed. Filling of all gaps and stabilization has also been done so that a surface could be prepared for a final finish.

The pigeon house is decorated with colored glazed tiles as found in the western and northern side of Picture Wall. The design pattern and choice of color were picked from the adjacent remaining pigeon holes in the Picture wall. The actual colors are matched with the original tiles colors. The glazed tiles used in the historical pigeon house are mix of ceramic body and terracotta base tile, fixed with different techniques of cutting and chiseling. The reconstruction of this pigeon house is done following the original design and proportions.

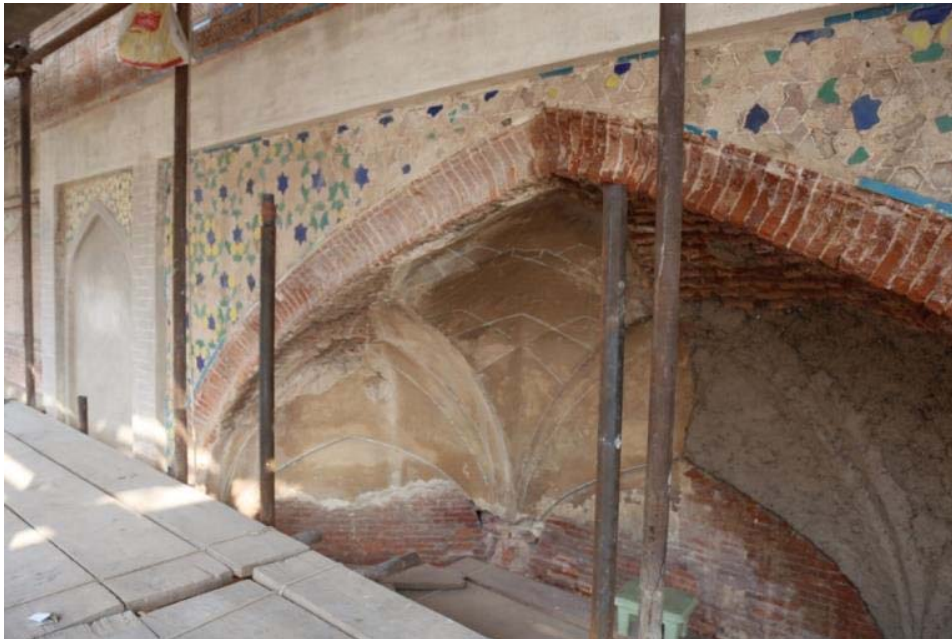
View of the Stalactite work before intervention

For stalactite work, brick structure is plastered after proper surface preparation in varying thickness according to various patterns. When the plaster is almost set, it is carved in with special types of craft tools. In the case of engraved lines, after the application of base and top layer of plaster the lines are engraved according with a sharp edge tool. The surface is then finished with glaze lime plaster.

The lower most part of prototype area (Iwan) has been plastered with stalactite work (Ghalib Kari) according to available evidence of Mughal period. The entire area of Iwan was covered with later additional cement plaster. Before starting the work, cement plaster was removed, exposing the layer of brick tiles in deteriorated condition. Replacement of fragile bricks with cut and dressed brick work has been done on the entire lower part of the prototype area.

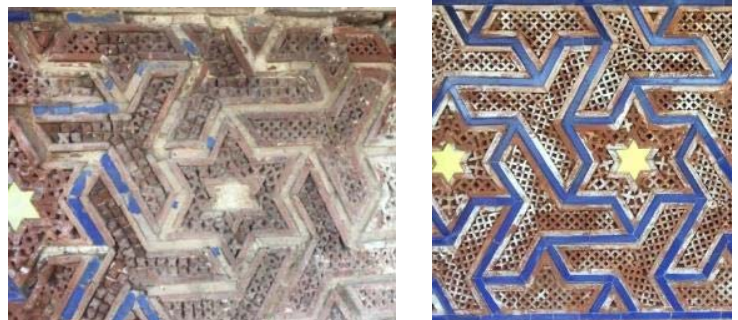
Upper Filigree with mosaic glazed tiles

Two horizontal friezes running through Picture wall have been restored with addition of missing carved brick pattern and glazed tiles matching the original color and design.

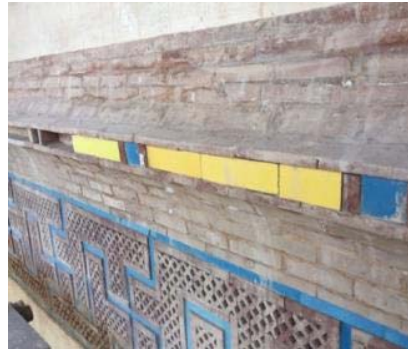
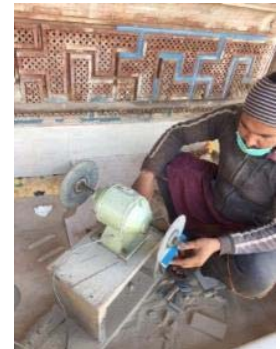
Restored Lower Filigree & cornice with mosaic glazed tiles

The restoration of lower cornice is done with filling missing and decayed brick tiles with cut and dressed bricks by keeping the original and replacing the glazed mosaic tiles in original color.

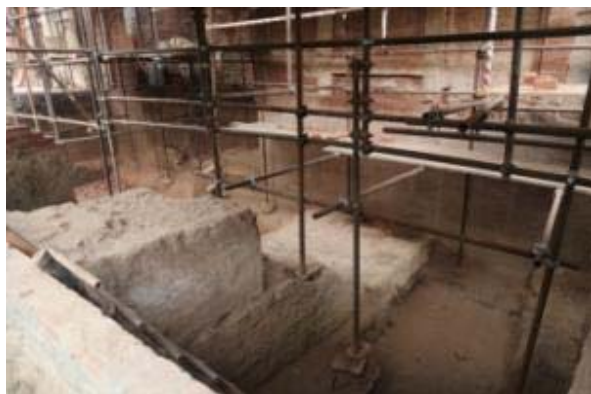
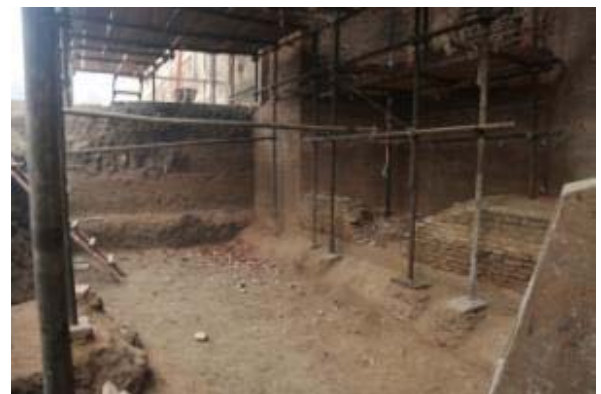
(Left): Barracks from the British era found in the excavation; (Right) Mughal era floor level in the excavation pit

The objective of the excavation work was to expose and study the original Mughal era floor level around the Picture Wall. For this purpose an exploratory pit was dug out under the selected prototype area so that examine the structure stability, and perform a complete study of the traditional construction techniques that consist of cut and dressed brick work, brick imitation work, and fresco painting underneath wall. These investigations made it possible to analyze the various interventions and changes made to the Picture Wall area during the post-Mughal Era including the British and Sikh Rule.

Now as a part of display, original floor level of Picture Wall which is more than 2 meters below the ground level has been exposed. This will help the wall to dry up as well as expose the whole length and proportion of the Picture Wall.

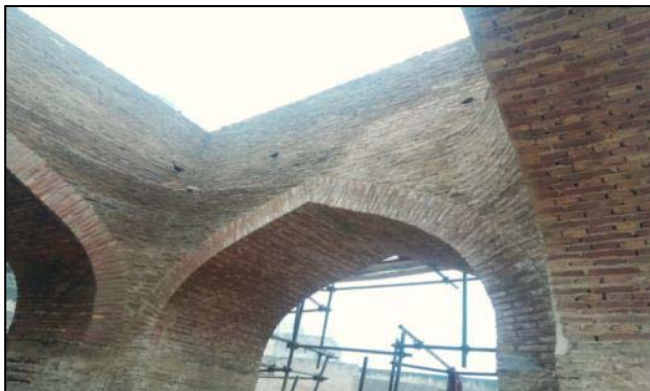
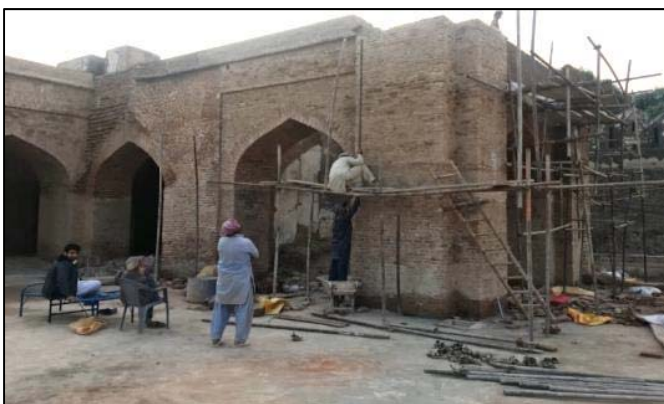
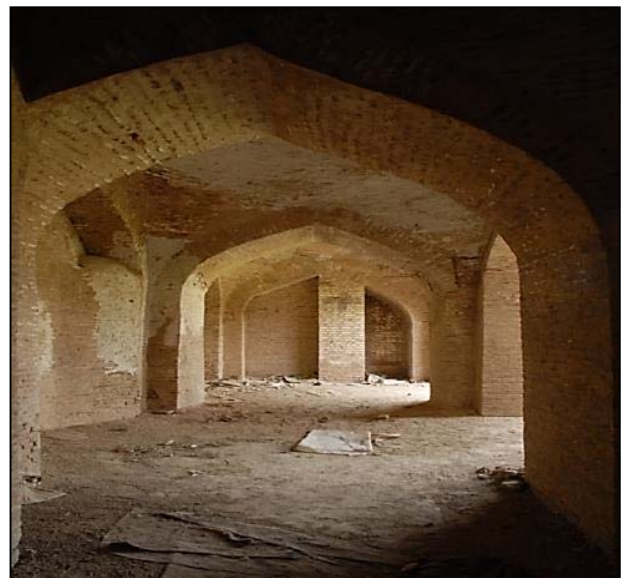
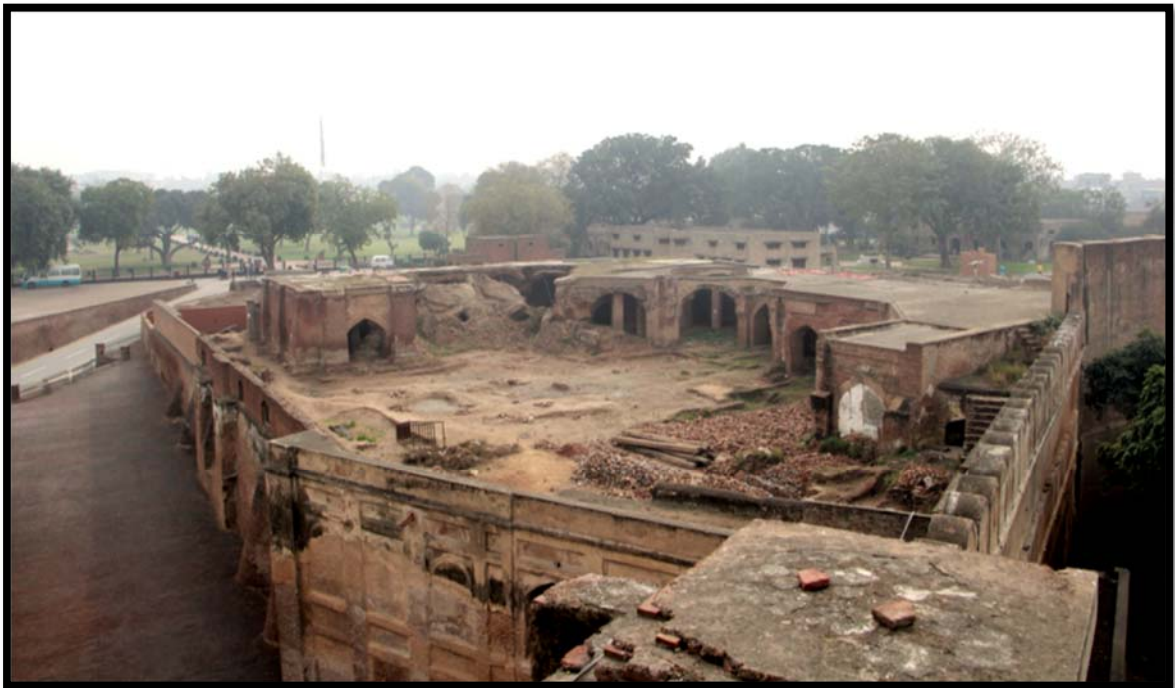
The following tasks have been completed

- Documentation of Building with Total Station and 3d Scanner
- Monitoring of structural movement & recording of cracks
- Recording of severely undermined structures and conservation proposal
- Soil Investigation
- Exploratory works
- Construction of Retaining wall in surrounding

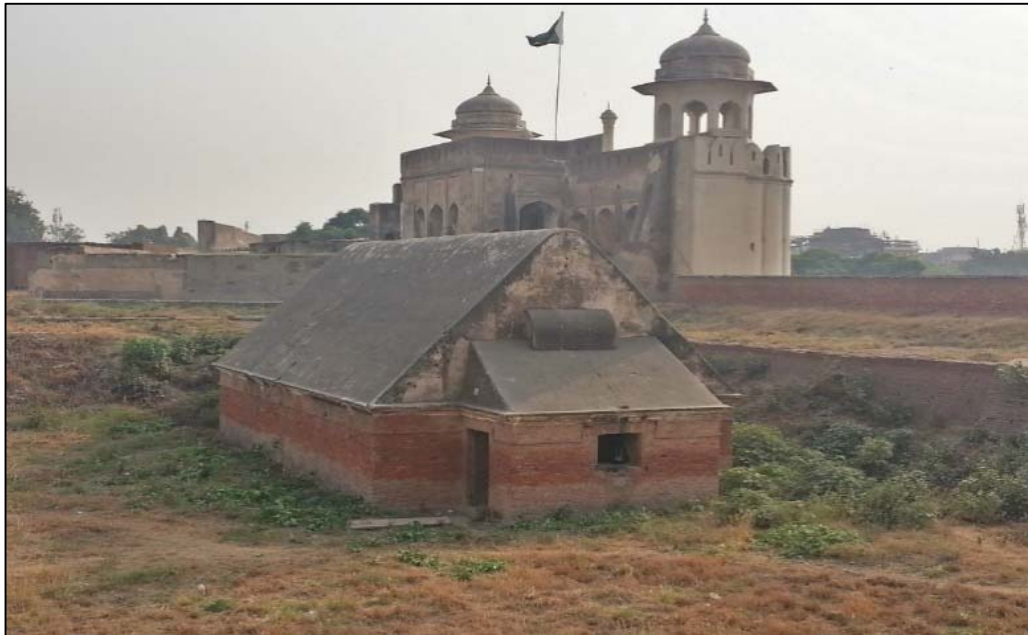
## **BAROOD KHANA**

Barrod Khana was built during British era in 1857 according to the plaque laid on the one of the entrance of barood khana. Purpose of this building was to store the weapons. The Barood khana is a single story building located at western side of Lahore Fort near Alamgiri gate and Musammam Darwaza.

- Architectural and Photographic Documentation of Building
- Structural Analysis
- Design Proposal

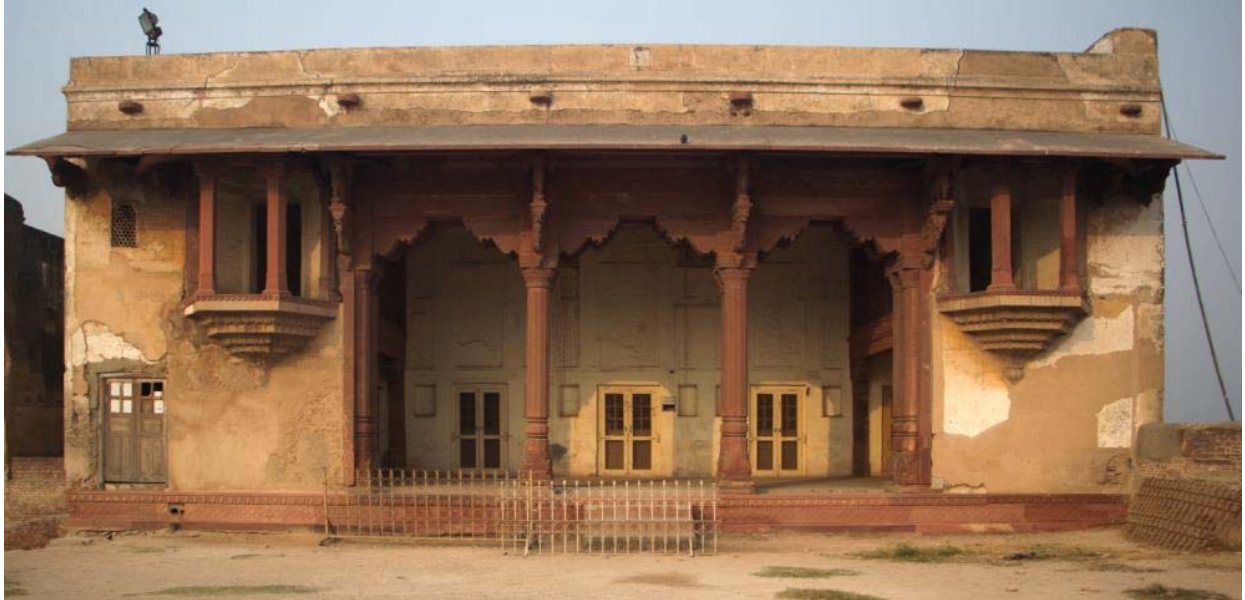
## WESTERN SUITS

Western suits are located in Jahangir quadrangle in Lahore fort. Built in Jahangir era. Walled City Lahore Authority (WCLA) has acknowledged the importance of the western suits and has taken the responsibility of sustainable conservation.

- Architectural and Photographic Documentation of Building
- Structural Analysis
- Design Proposal

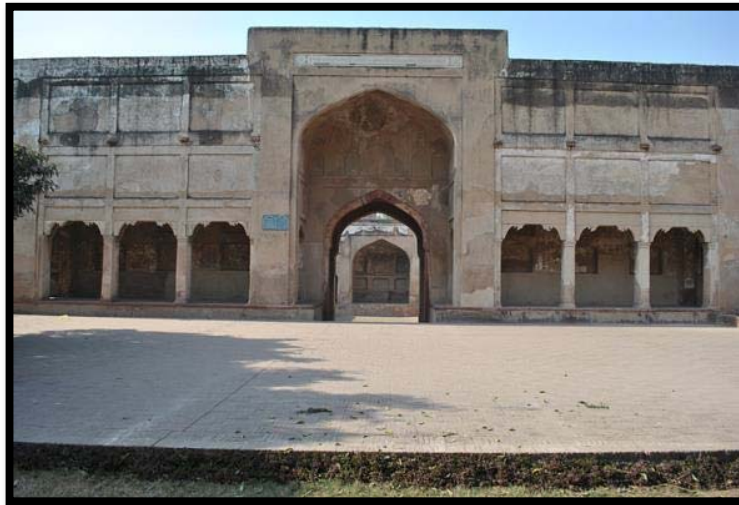
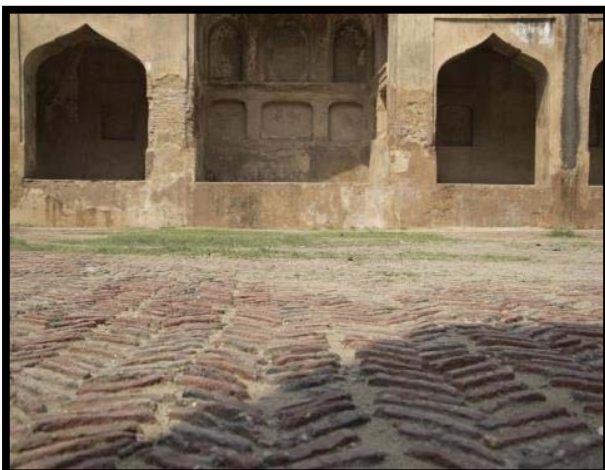
## **MAKATIB KHANA**

The Maktab Khana is a small cloistered court immediately adjacent to the Moti Masjid. It is a Persian-style compound with pointed-arch arcades and deep iwans at the center of each of the four sides. However, an inscription found above the main entrance records that it was built under the supervision of Ma'mur Khan in 1617-18 and identifies the site as the "Daulat Khana-i-Jahangiri", the "Residence of Jahangir". It is therefore likely that the Maktab Khana is a surviving fragment of a much larger mansion complex serving the Emperor.

- Architectural and Photographic Documentation
- Structural Analysis
- Remedial measure for vegetation growth
- Restoration of Monuments

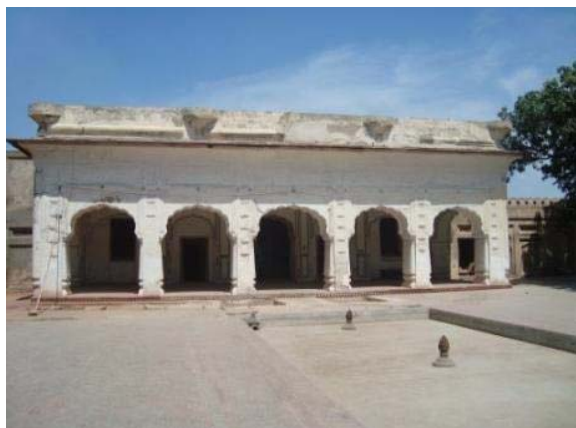
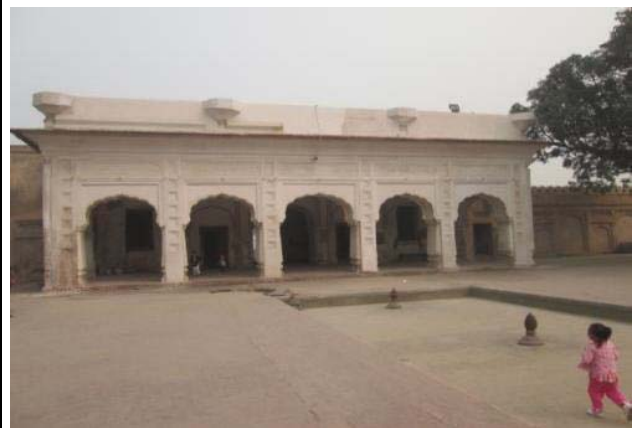
**Before Conservation**

**After Conservation**

The Naqqar khana Complex is the integral part of the Shalamar Gardens located on the eastern side of the garden. It was used for the all official activities during the presence of Emperor Shah Jahan, as government secretariat. All important announcement and official order were issued from this place. After the completion of the Parking and Public Utility area at the eastern side, entrance of the tourist has been shifted through Naqqar Khana Complex therefore became first appearance to the visitor. Condition of this pavilion was not upto the desired conservation standards. Therefore a new project to the cost of Rs. 6.154 million ( \$ 0.057 million) was initiated in the year 2016-17. Under the scheme restoration of decayed plaster, pucca kali and walkways has been conserved. Decayed floor of the Naqqar Khana pavilion has been restored to the original geometrical. Wooden doors at the southern side entrance of the complex and inside have restored. On the eastern exterior side boundary with iron fence has been erected to control encroachment, trespassing. Brick on edge flooring has been laid to control water penetration on the area between the southern perimeter wall and boundary wall. Roofs of the have been water tightened with lime terracing and lawn inside have been developed. After the completion of the project this part of the Garden not only preserved but also upgraded to a presentable look.

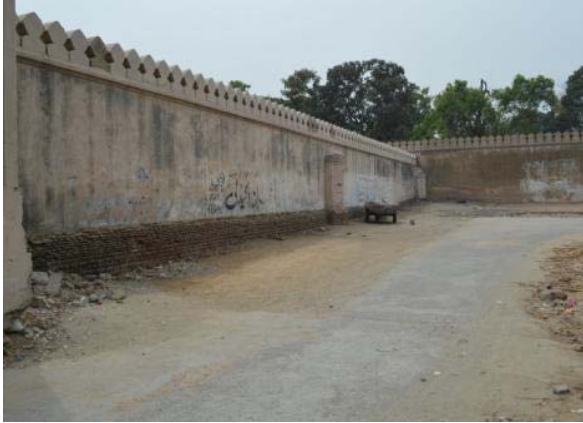
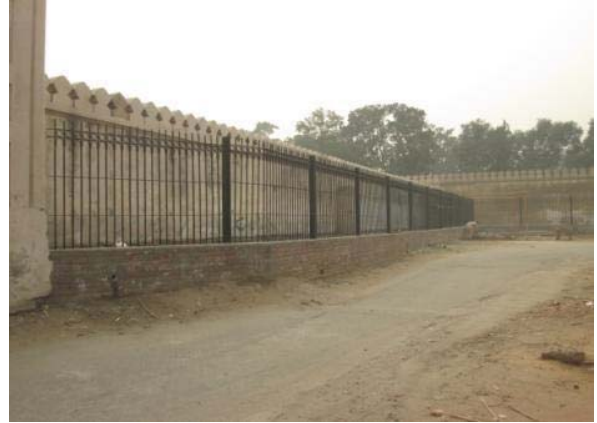
**Fixing of iron grill & Plinth Protection on exterior side of perimeter wall of Naqqar Khana**

**Before**

**After**

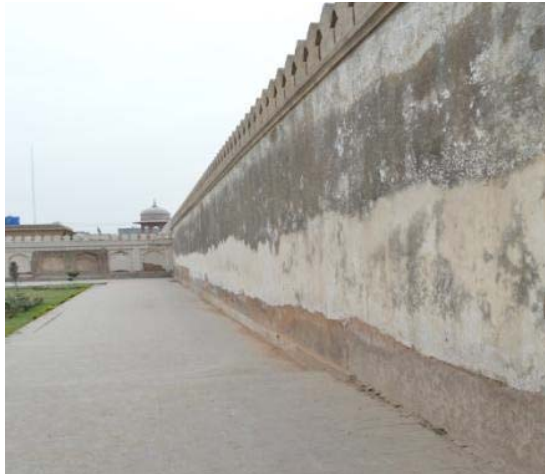
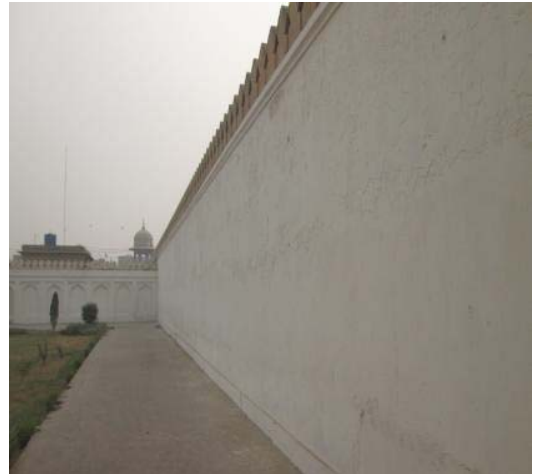
**Conservation of Lime Plaster of Perimeter Wall of Naqqar Khana**

**Before Conservation**

**After Conservation**

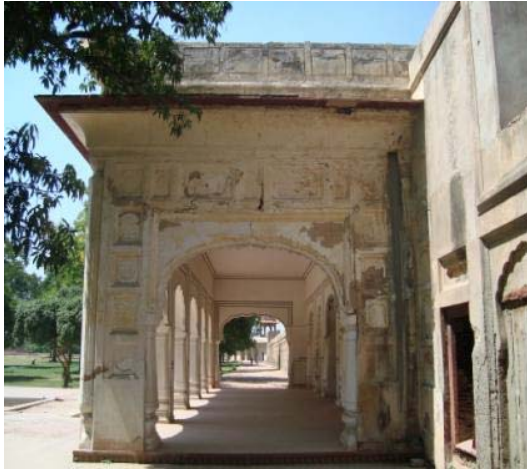
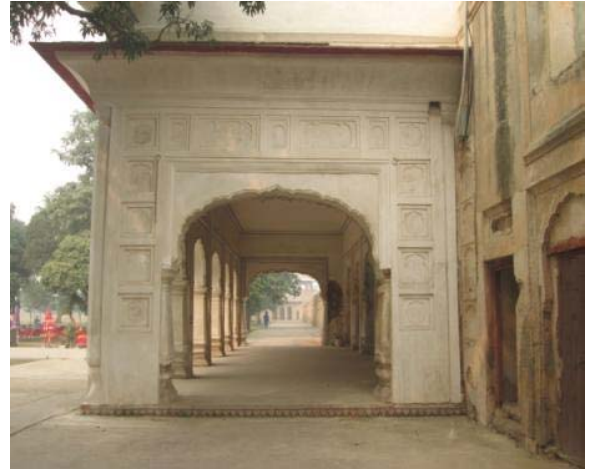
### Conservation of Pavilion of Naqqar Khana Complex

**Before Conservation**

**After Conservation**

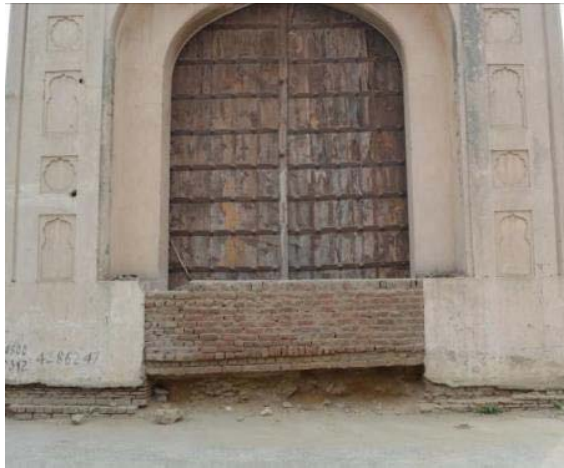
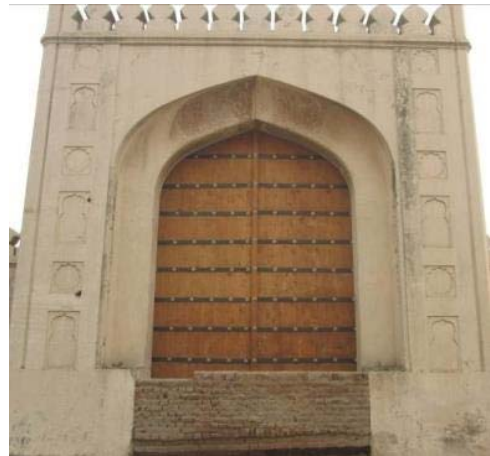
### Restoration of Wooden Gate of Naqqar Khana Complex

**Before Conservation**

**After Conservation**

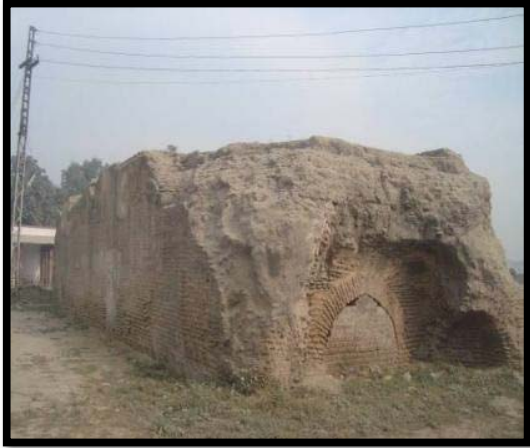
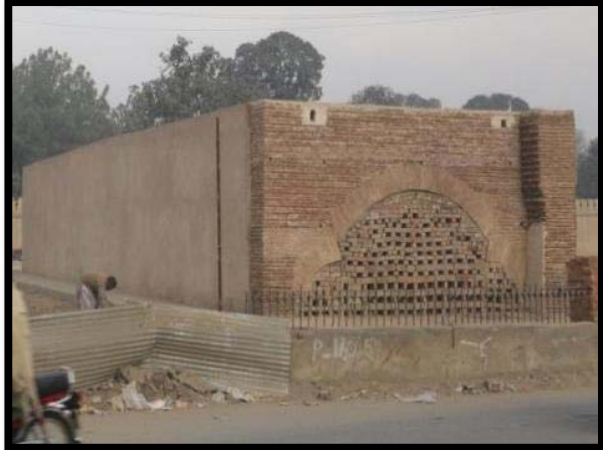
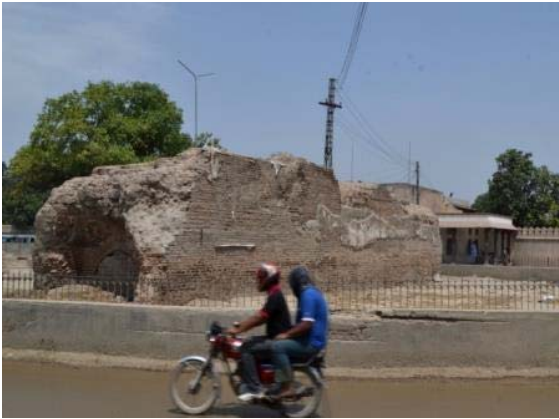
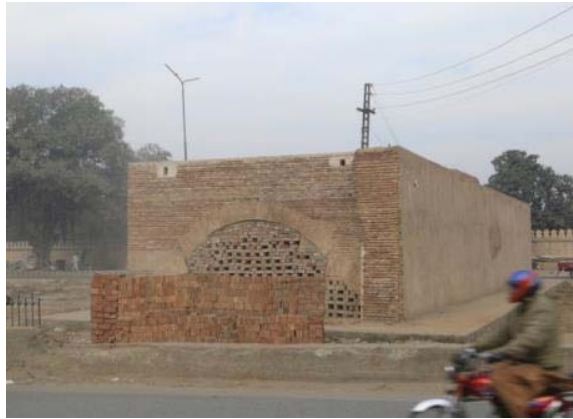
| Preservation of Hydraulic Tank | |

| Preservation of Hydraulic Tank | |
|---|---|
| Before Conservation | After Conservation |

Major part the project particularly preservation and restoration of remnants of old hydraulic structure has been completed. Structure has been consolidated by underpinning, lime plaster has been restored and roof has been laid with lime terracing to avoid moisture penetration. Plinth protection has been provided around the structure for the restriction of any water penetration to the foundations of the monument. Construction of boundary wall with iron

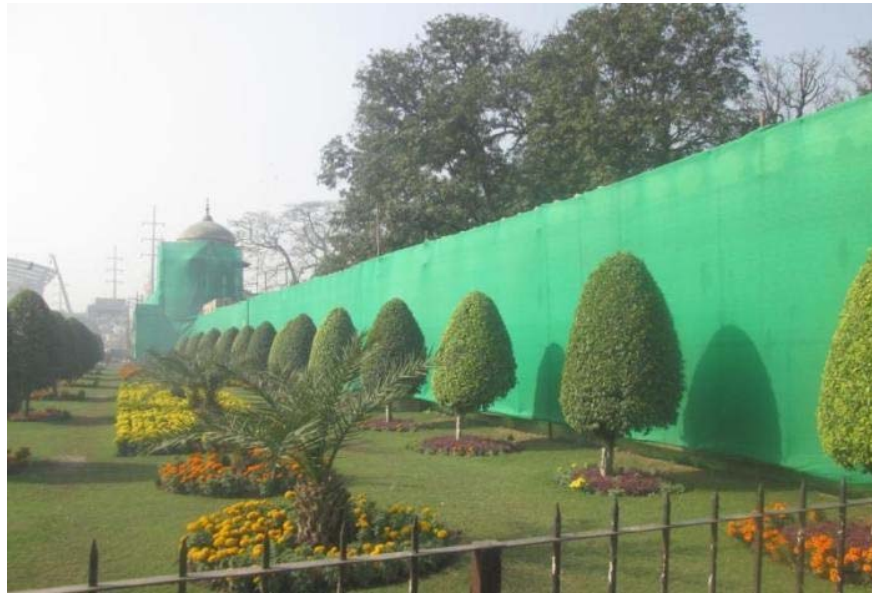
### **Bracing & Netting / Sheeting Arrangements at Shalamar Gardens**

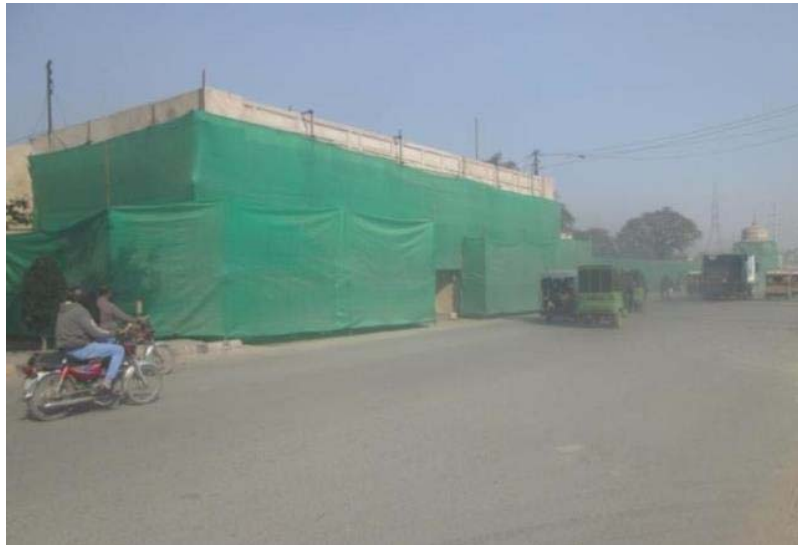
### **Bracing & Netting / Sheeting Arrangements at Shalamar Gardens**

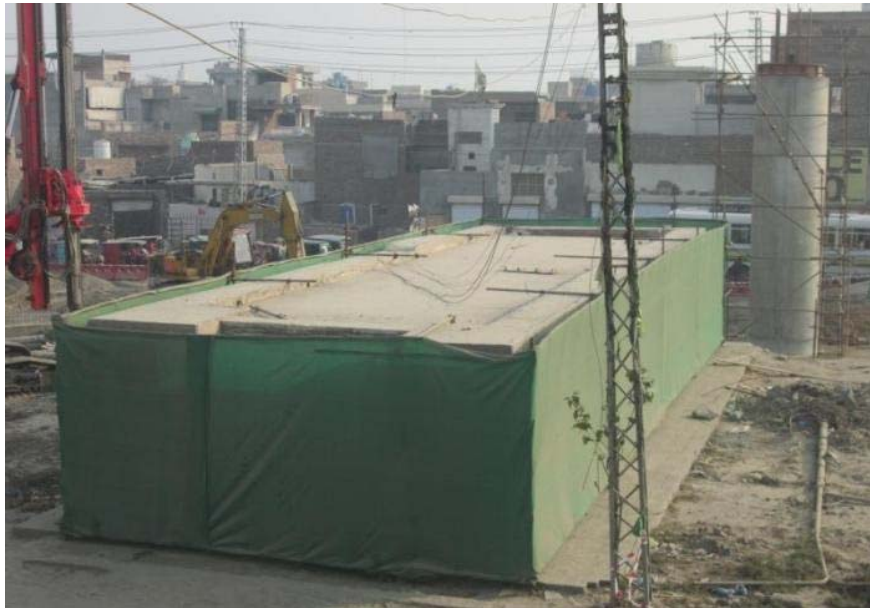
**Bracing & Netting / Sheeting Arrangements at Hydraulic Tank**

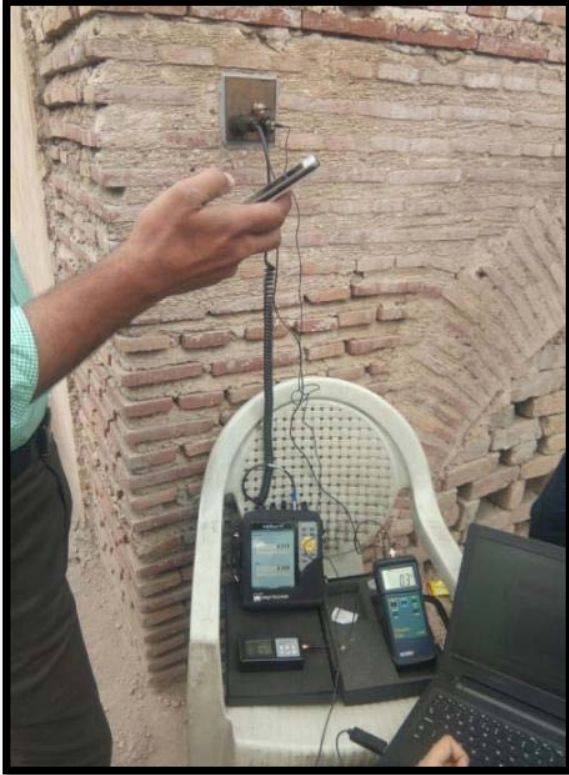
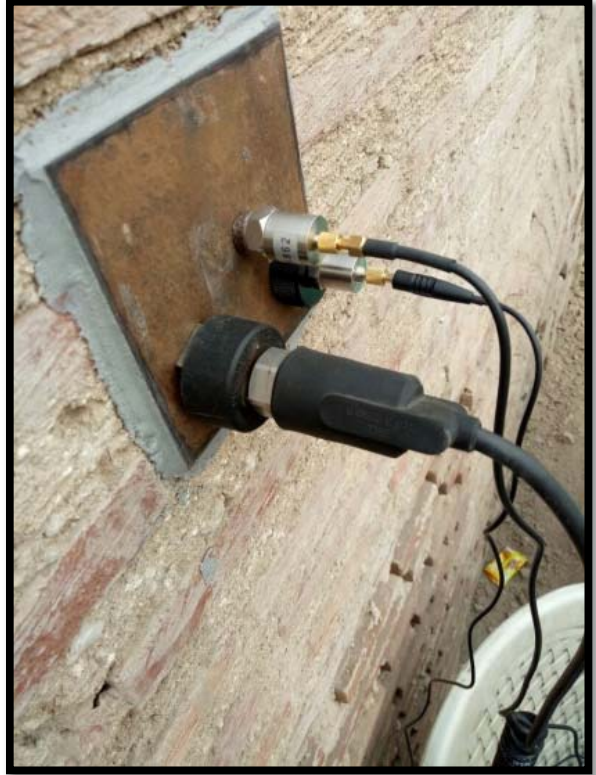
**Equipment Installed at Site for Monitoring**

To ensure implementation of additional mitigation and remedial measures as mentioned in vibration analysis, necessary equipment have been installed to record vibration, noise, cracks, settlement and deflection of any part of the monument. A high level Special Committee of Expert has been constituted under the supervision of a retired Judge of Supreme Court, comprising Principal National College of Arts, Chairman Archaeology Department University of the Punjab, Head of Structure Division, Civil Engineering Department University of Engineering and Technology, Lahore and Director General Archaeology, Punjab, to oversee the implementation of the Judgment and directions of the Honourable Supreme Court for making recommendation to undertake measure as may be necessary for the safety of the monuments. After the resumption of construction work of OLMT project, a dedicated technical team of experts comprising of a structural engineer, an experienced archaeologist and conservationist has also been appointed to
